IOC / OdinAfrica / GLOSS

Technical Visit to Madagascar and Comoros

28 April to 10 May 2006

Frédéric SIMON
Surveyor
France

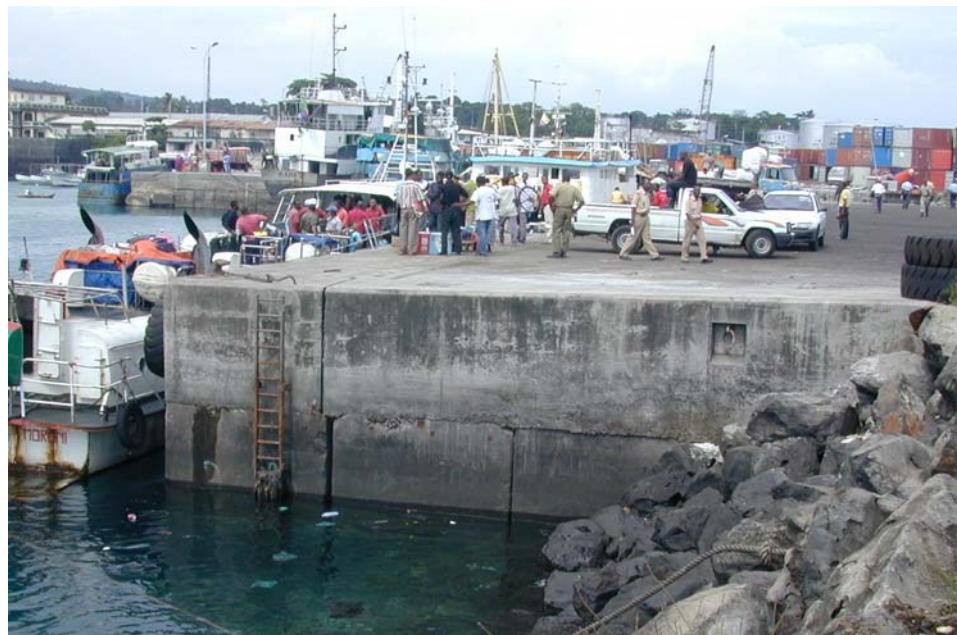
Figure 12 : View of the new pier of the port of Moroni (at left behind, the old first pier of the port)
There is not enough water depth to install the tide gauge here and the concrete blocks are collapsing into water
